32 Mill Street Net-Zero Energy Retrofit

Warrior Home
Solar Decathlon Team

U.S. Department of Energy
Solar Decathlon 2023 Build Competition

Engineering Narrative

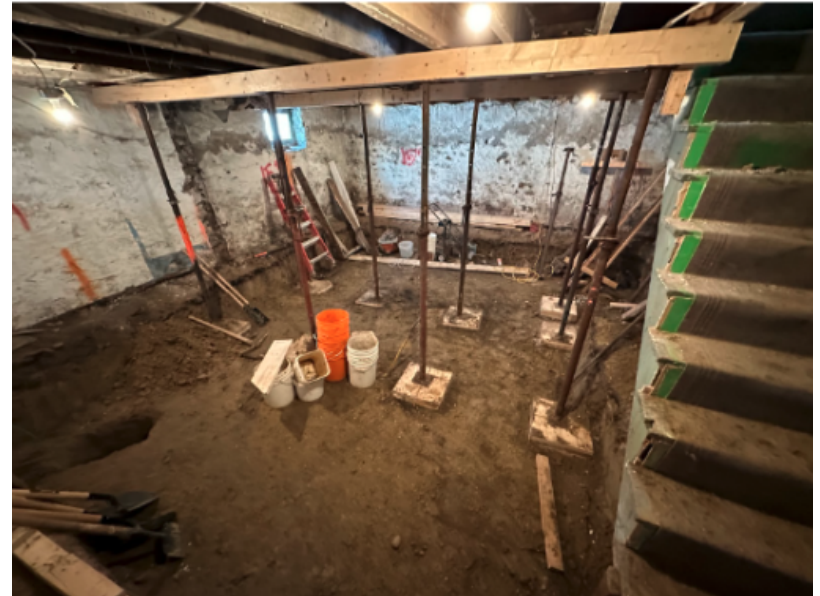
In collaboration with the architecture team, the house's floor plan was redone while maintaining the home's existing load bearing walls. Additionally, due to the existing stairs not being code-compliant (specifically between the basement and the first floor due to the angle of the stairs being over 45 degrees (according to OBC 3.4.7.5)) many of these stairs needed to be rebuilt to fit existing guidelines. These stairs, the partition walls, the beams, as well as the floor joists were reframed with newer pieces of lumber.

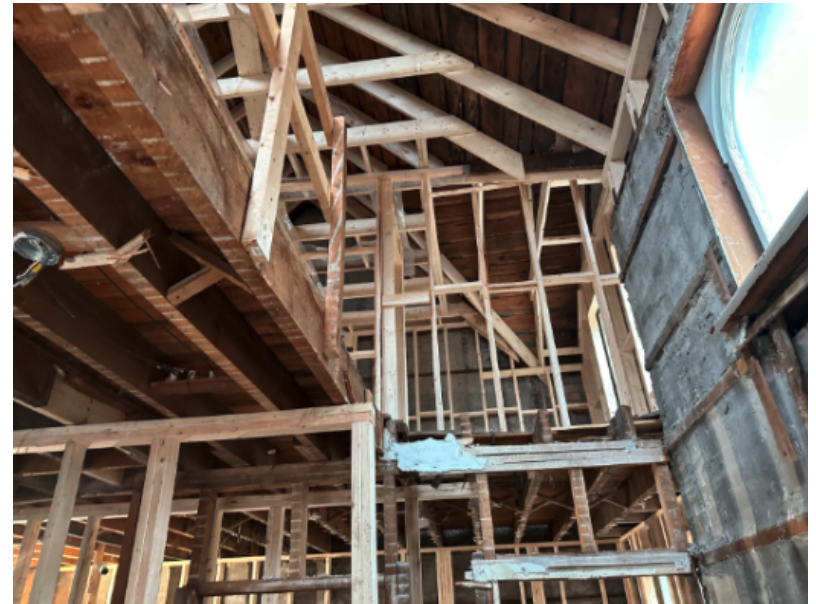
The existing house included a porch, however it did not include a deck which was a want of our client, Kitchener-Waterloo Urban Native Wigwam Project (KWUNWP). New posts along with footings had to be installed for the construction of the deck at the back of the house. Formadeck vinyl deck boards was used as the decking material, which complied with the City of Kitchener's requirements. The spacing of the deck's joists were determined by its span. The wood for the porch was completely replaced with Formadeck vinyl deck boards as well due to rotting.

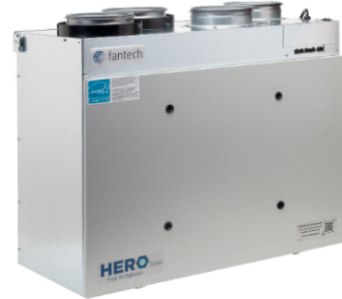
GE/ Haier Connect
Air-Source Heat Pump

For the building systems, we will be decarbonizing the home by replacing the existing natural gas equipment with a cold-climate air-source heat pump coupled with a heat recovery ventilator. Due to the asbestos found in the existing ductwrap, the ductwork will be replaced by an improved layout. Air will be distributed by a central air handling unit in the basement to avoid oversizing equipment. The heat pump features a backup 8 kW electric heater in the event of extremely cold temperatures below -22 degrees fahrenheit.

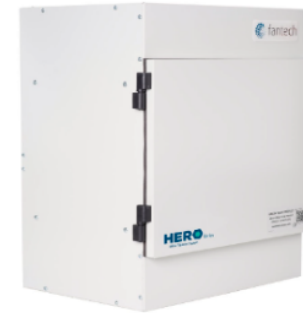
HERO 150H HRV

The HRV will utilize a hybrid ducted system with the AHU, with dedicated spot ventilation in the bathrooms and general return from common spaces for better air circulation. To improve the indoor air quality, a bi-polar ionization device will be installed at the AHU supply duct to filter out any pollutants and particulate matter.

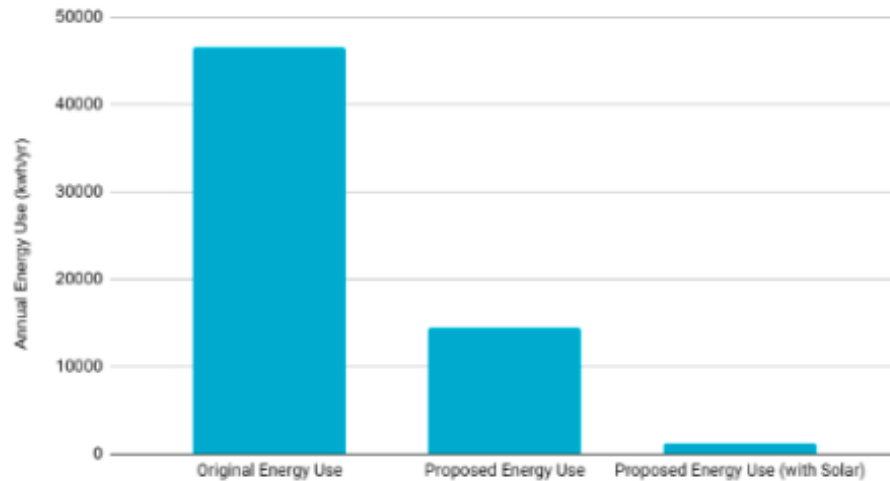
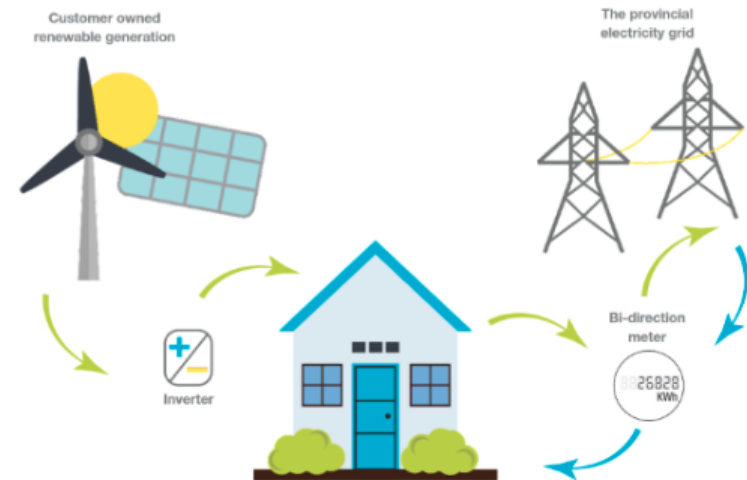
The proposed PV array is 10.9 kW. A total of 28 Trina Solar TSM 390 modules are to be flush mounted to the roof with a Fastrack aluminum rail system. The rail system is well suited for the somewhat complicated panel layout on account of the existing roof shape. A protective array perimeter meshing will be installed to provide physical protection from environmental factors such as high winds or falling debris and to deter animals from the array.

The system overall is estimated to produce about 11,000 kWh per year.
