FUNNEL
HOUSE

SOLAR
DECATHLON

TEAM: INDOAMÉRICA

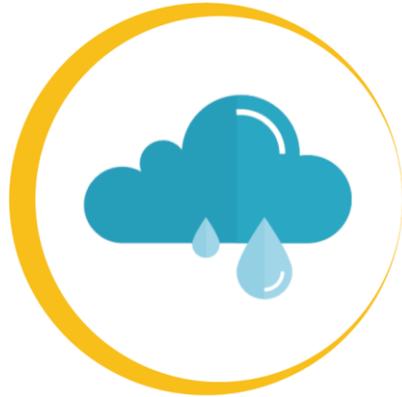
Humidity: 81%-92%

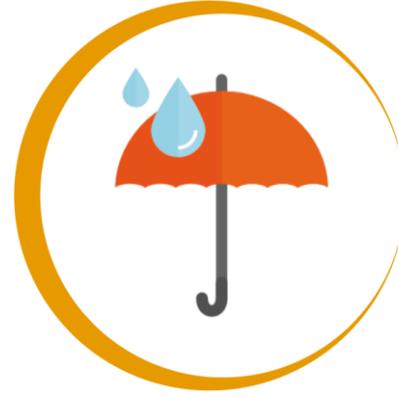
Maximum precipitation:
38553.1 mm

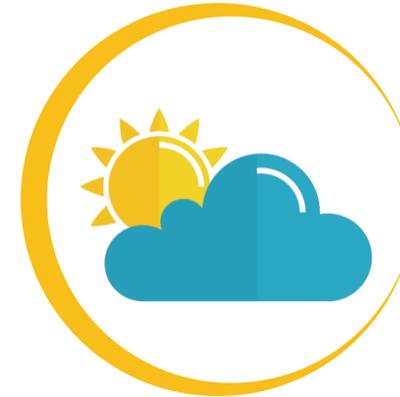
Months with high cloudiness:
February and July.

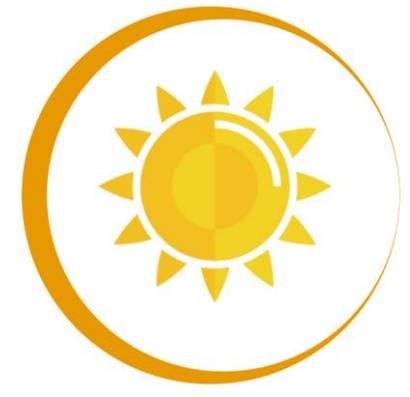
Months with the most hours of sunshine per day: tropical:
July and August.

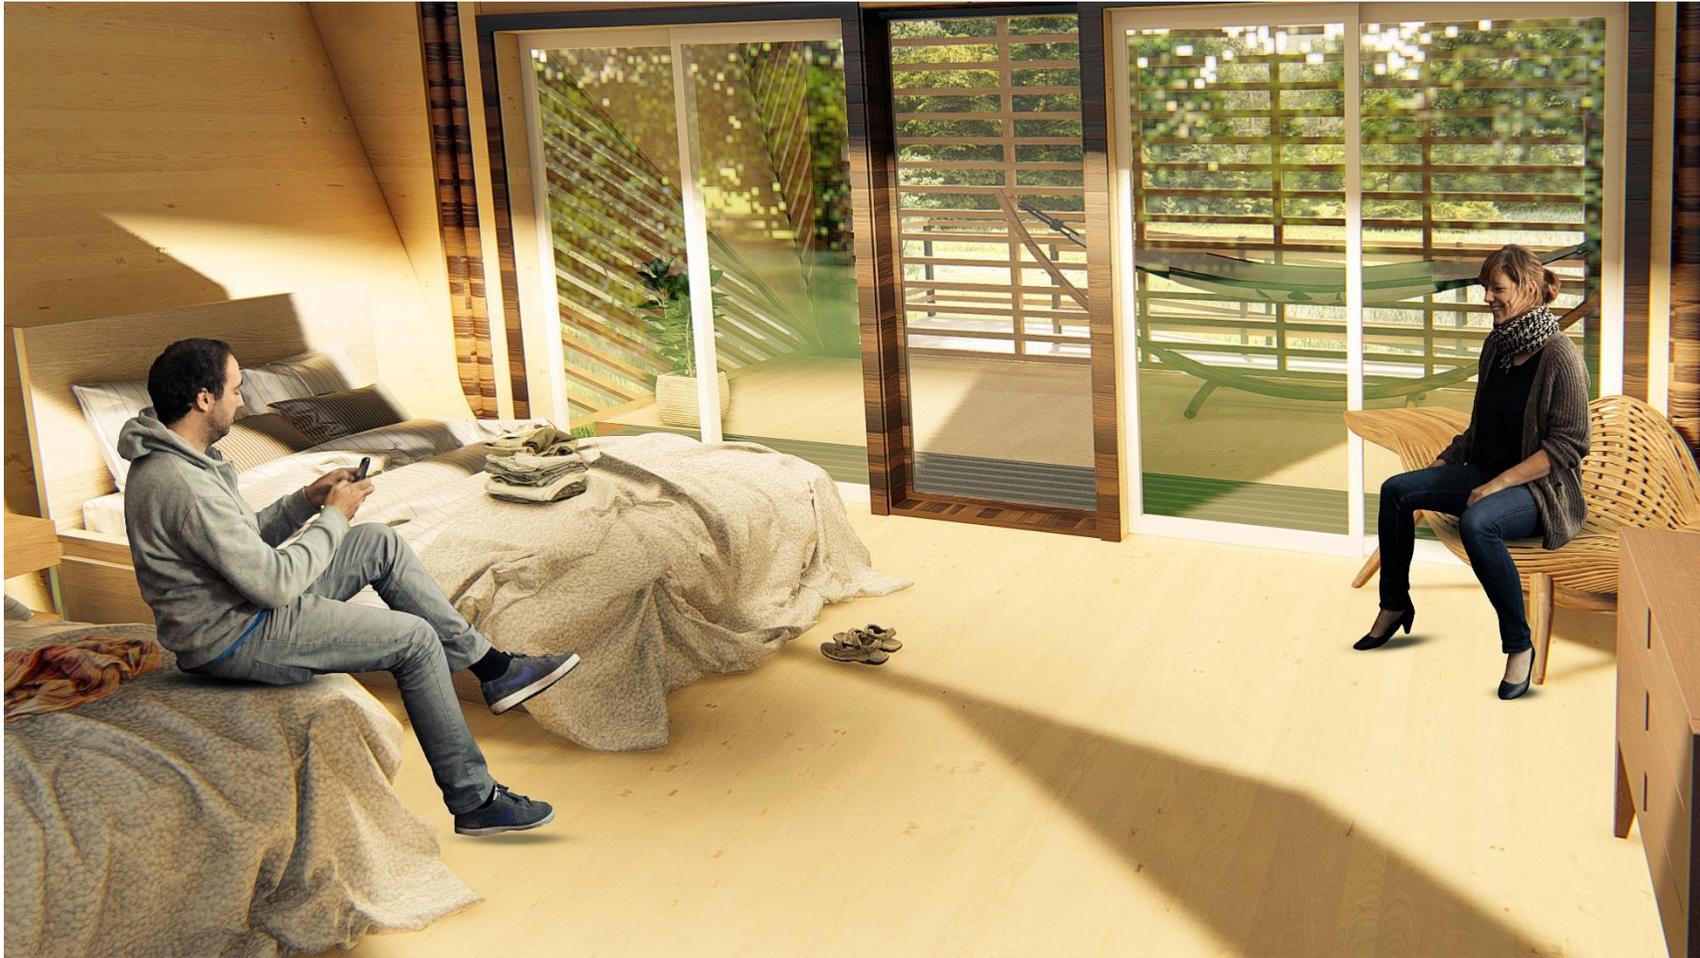
MATERIALITY IN INTERIOR DESIGN

OSB Or Oriented Fiber Boards

Bamboo

Ecological stucco of cal

Narrow Slatted toasted bamboo board -VT

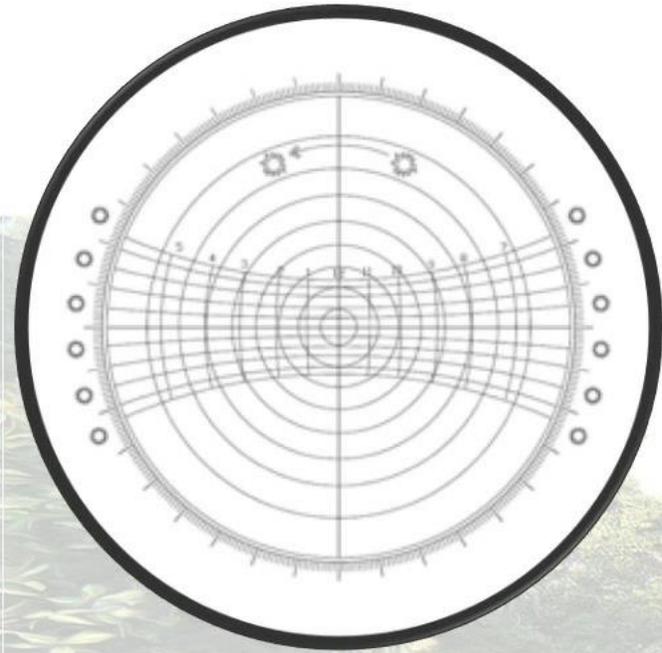
Latitude 0°
High solar irradiation

FV energy production House's energy consumption Excess returned to grid
5807 kWh/year - **4338 kWh/year** = **1469 kWh/year**

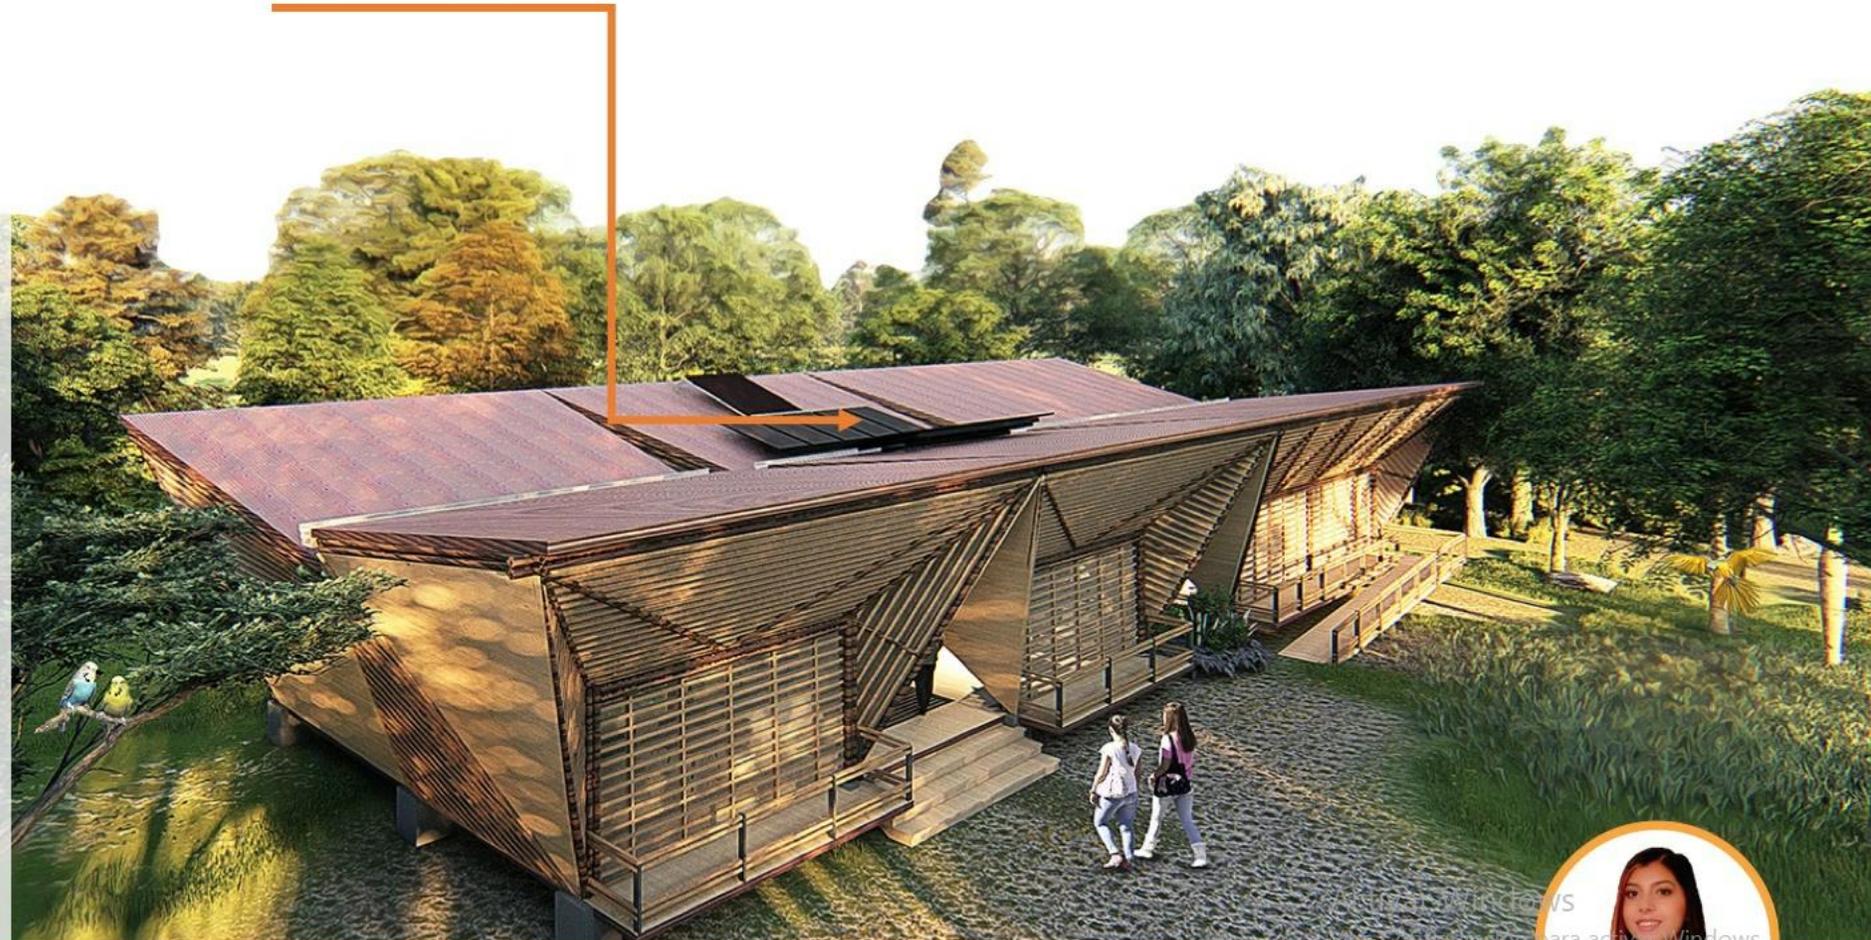
Fuel Breakdown - TENA- ECUADOR, FUNNEL HOUSE

1 Jan - 31 Dec, Run period

EnergyPlus Output

Evaluation

Room Electricity (kWh)	1225,89
Lighting (kWh)	741,43
DHW (Electricity) (kWh)	1673,76

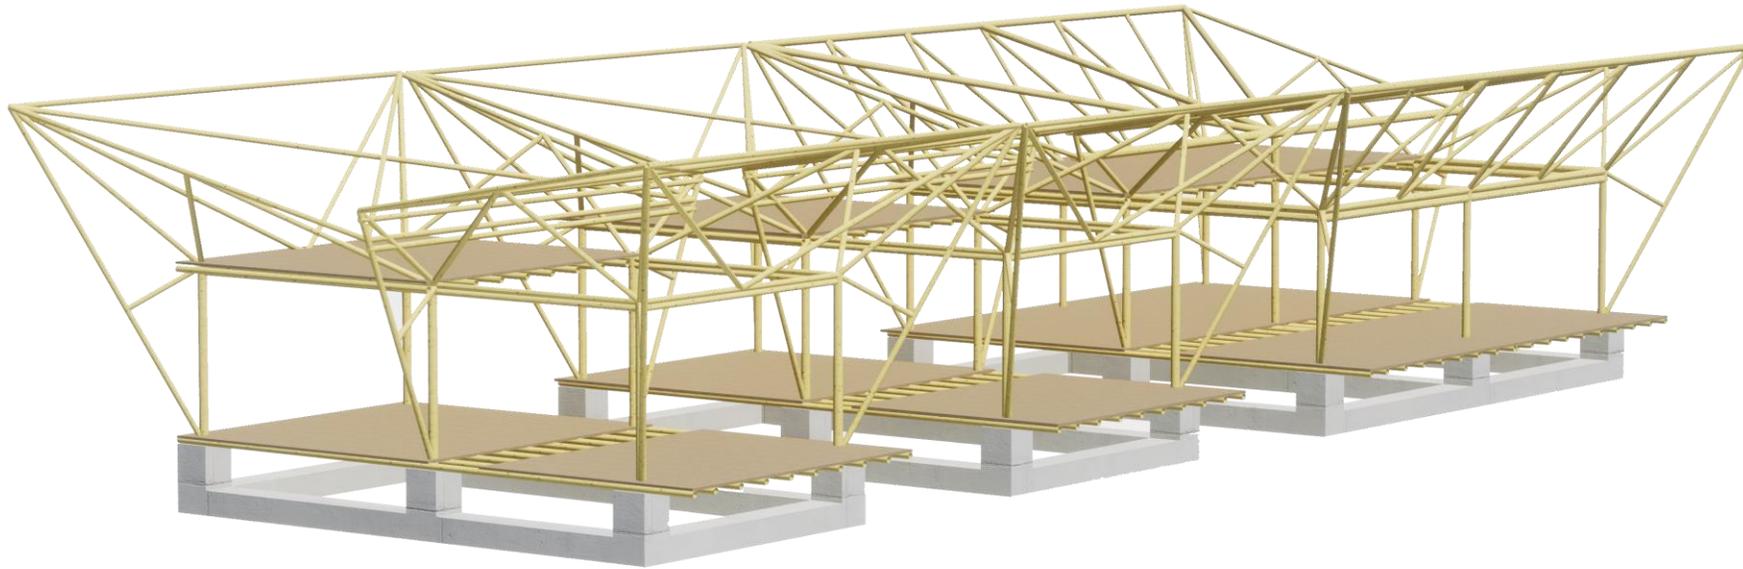
STRUCTURE

Exo - Structure

Concrete Foundation
Bamboo Structure

Wall System

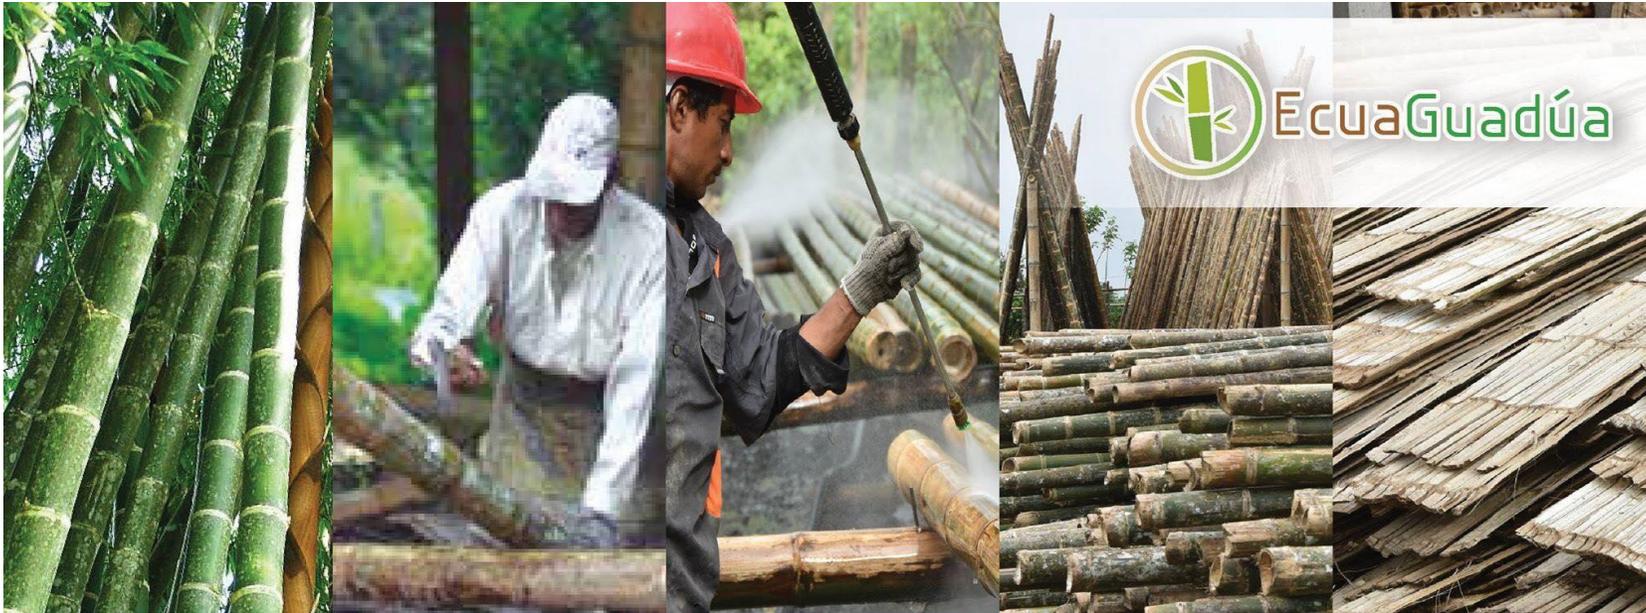
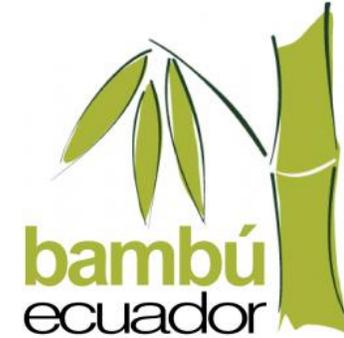
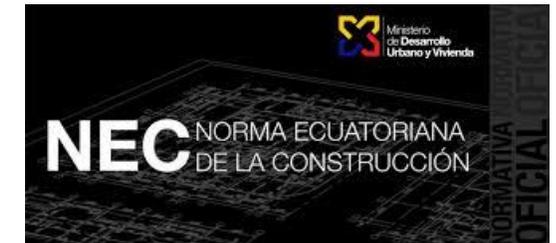
BAMBOO -GUADUA ANGUSTIFOLIA

Lifetime	Stem Height	Diameter Radius	Compressive strength	Compression elasticity module	Felxural modulus
50 years	91.86 ft	0.49 ft	37.76	14.35 Gpa	12.16 Gpa

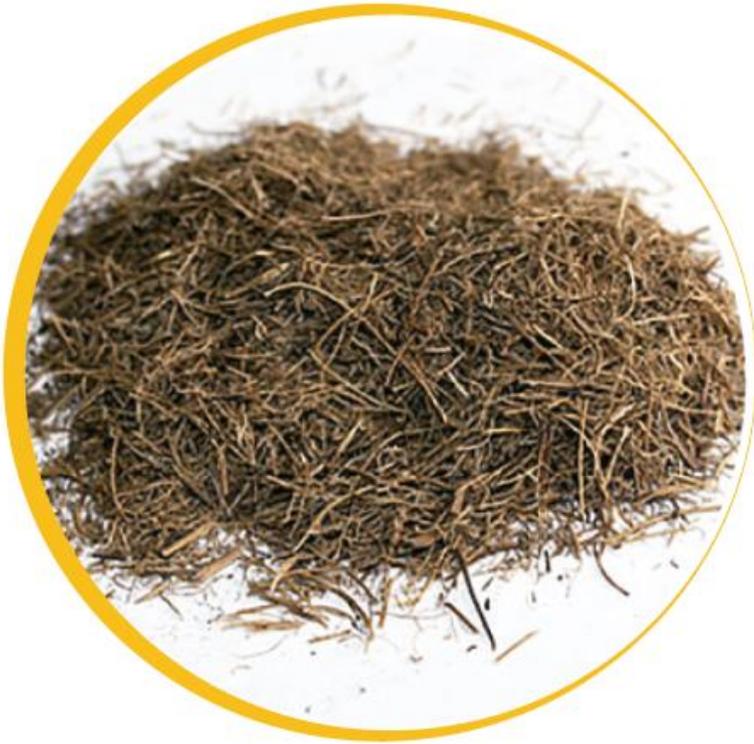
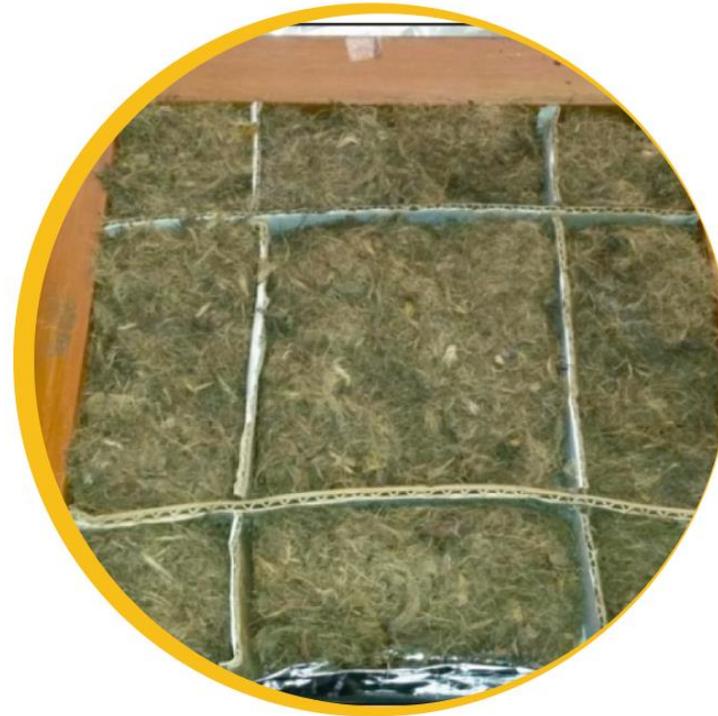
PALM FIBER

Natural fiber used as insulation for temperature, research by ESPE University

Palm fiber insulation
research

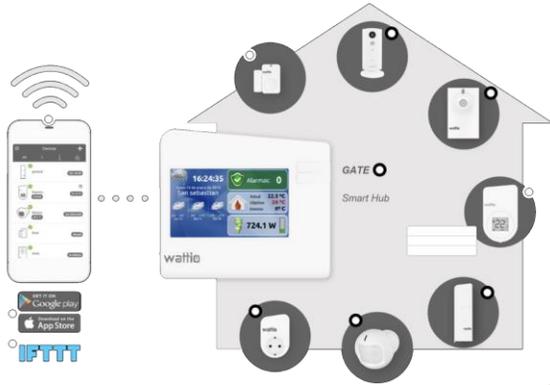
Intelligent
plug

integrates with all devices

SAAS (Software as a service)

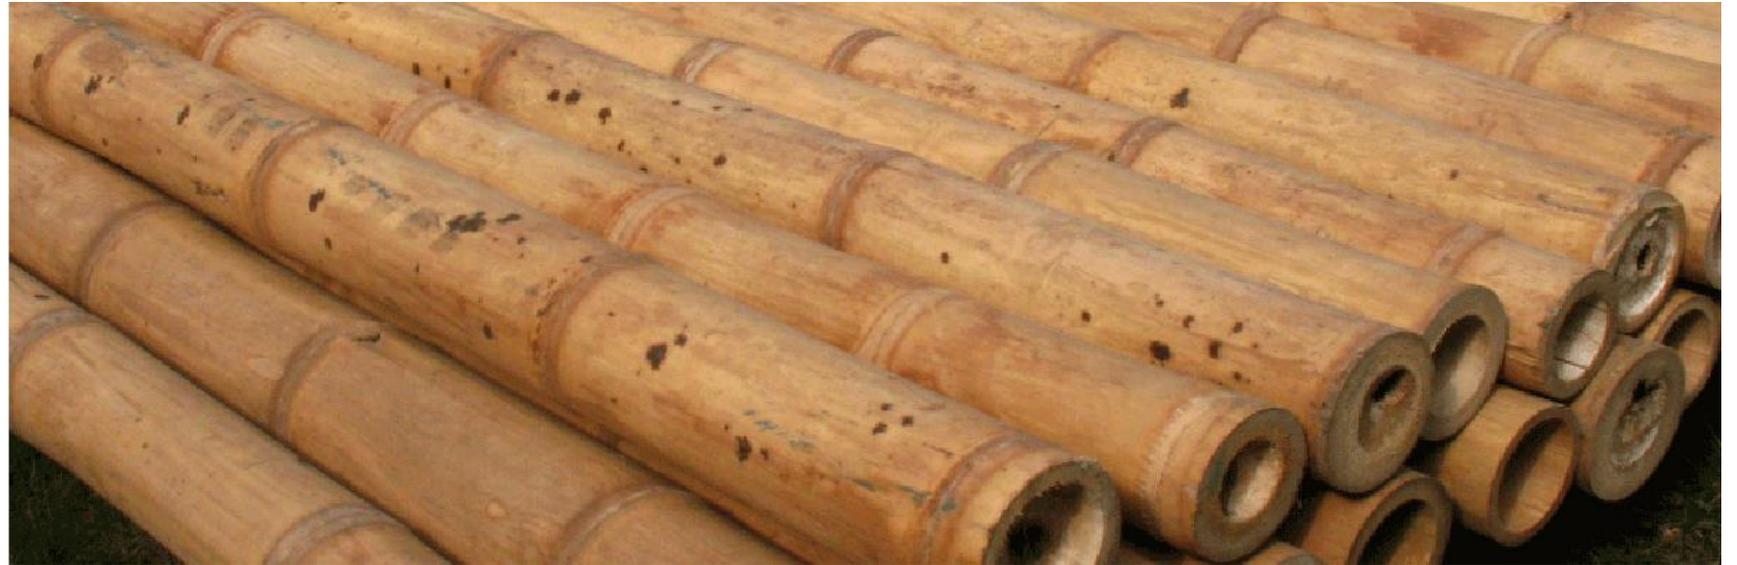
TREATED BAMBOO

Palm oil
Water proofing

Zinc or Titanium
UV protection

Wax finish
Dust protection

MATERIALS	USE	LIFETIME	MAINTENANCE TIME
BAMBOO	STRUCTURE	50 YEARS	EVERY 2 YEARS
PANLES OSB	WALLS - FLOORS	40 YEARS	EVERY 2 YEARS
SANWICH TYPE METALLIC PANEL	ROOF	25 YEARS	EVERY 2 YEARS

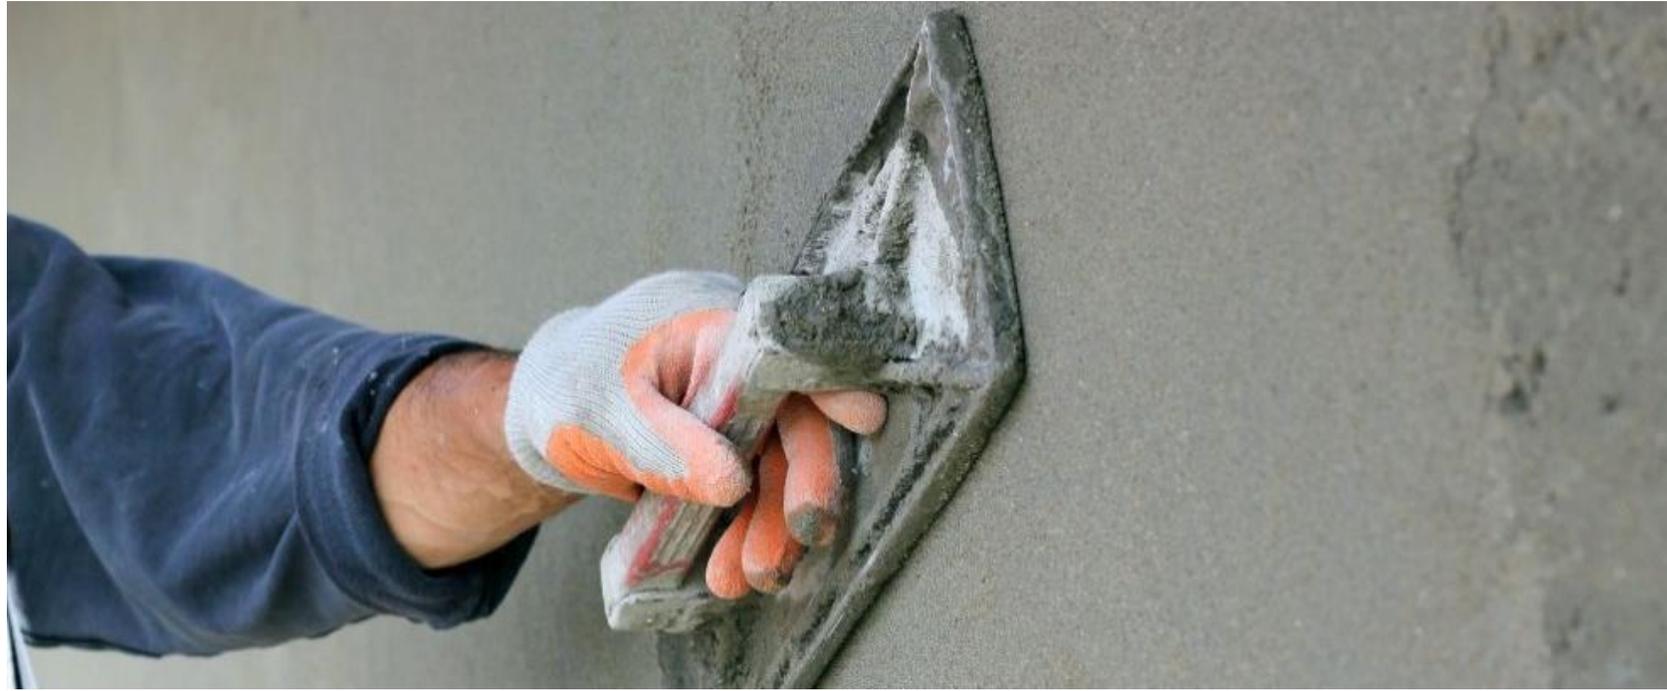
WATER RESISTANT STUCCO

3mm (0,1 inch) layer

Maintenance every 2 years

40 years lifetime

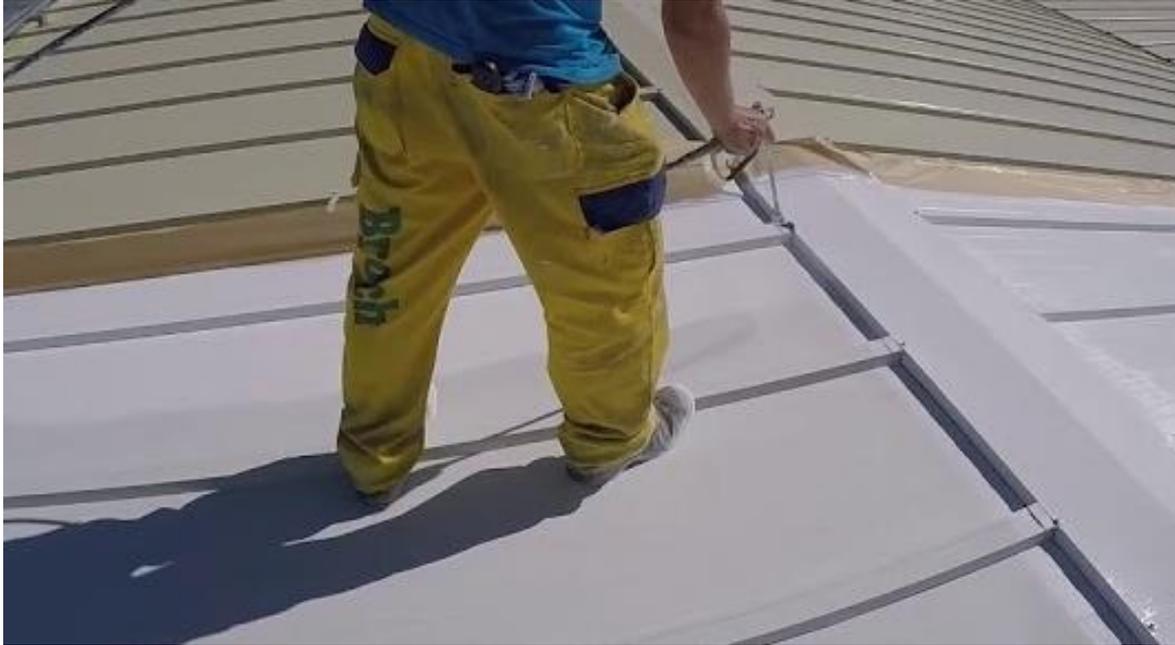
ROOF PROTECTION

Protective Paint

- Reflects radiation
- Improves thermal and acoustic insulation
- Moisture control

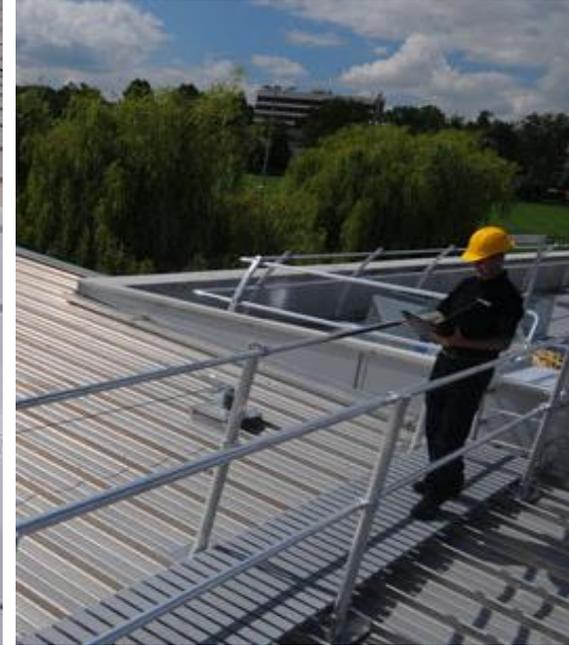
Service ladder

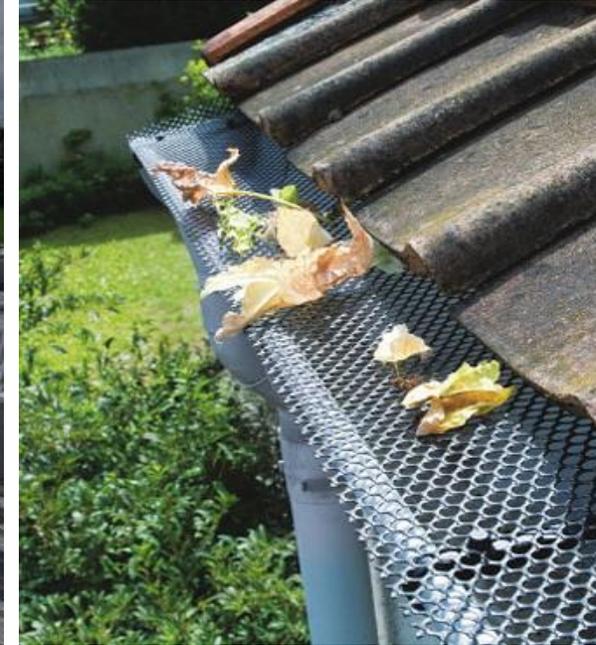
Gutter net
